Manhole Inspection Summary

Manhole # S13CC_017MH

Insp Date: **7/10/08 1:32 PM**

Location Address: **2878 WINCHESTER ST** Cross Street: **POPLAR GROVE ST**

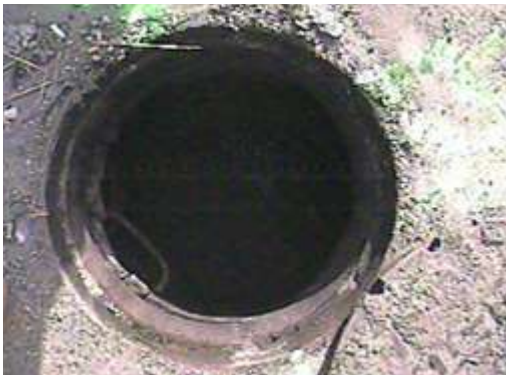
Defect 3

Frame Offset: **2** (in.) Condition: ☒ Sound ☐ Cracked ☐ Leaks

FRAME OFFSET

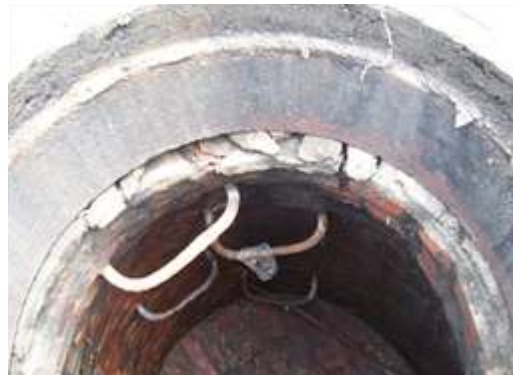
Defect 2

Surcharge ☒ **Evidence Of Surcharge** Depth: **3** (ft.) ☐ Active Surcharge Present

EVIDENCE OF ACTIVE SURCHARGE
AND CHIMNEY LOOSE BRICKS

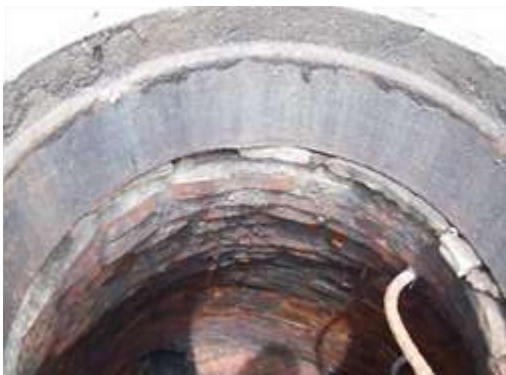
Defect 1

Condition: ☐ Sound ☒ **Cracked** ☐ Root Intrusion ☒ **Loose Brick** ☐ Deteriorated

CRACKED CHIMNEY AND LOOSE
BRICK

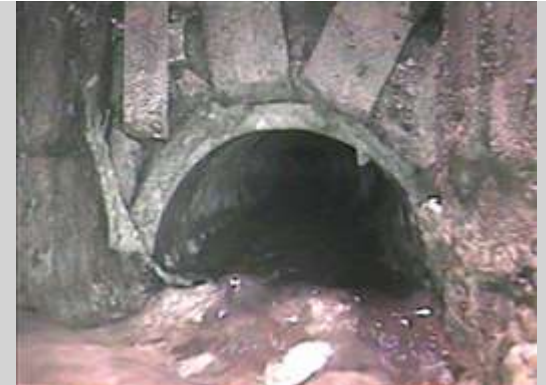
12 O'Clock Outflow

8 in. Circular Gravity Sewer
Pipe Out @ 12 O'Clock

Pipe Height: (in.) Direct
Pipe Material: **Clay** ☐ Pipe Lined
Invert Depth: **7.08** (ft.) Flow Characteristics: **Fast**
Deposits: ☐ None ☐ Mud ☐ Gravy ☒ **Debris** ☐ Grease
Silt Depth: **2** (in.) Deposits Extent: **Light**
Infiltration: **None** Pipe Seal Cond: **Sound**

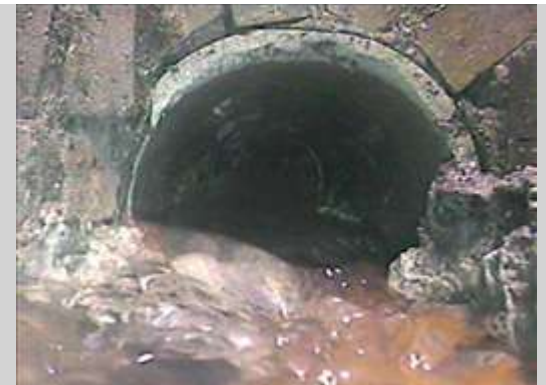
3 O'Clock Inflow

8 in. Circular Gravity Sewer
Pipe In @ 3 O'Clock

Pipe Height: (in.) Direct
Pipe Material: **Clay** ☐ Pipe Lined
Invert Depth: **7.02** (ft.) Flow Characteristics: **Fast**
Deposits: ☐ None ☐ Mud ☐ Gravy ☒ **Debris** ☐ Grease
Silt Depth: **2** (in.) Deposits Extent: **Light**
Infiltration: **None** Pipe Seal Cond: **Sound**

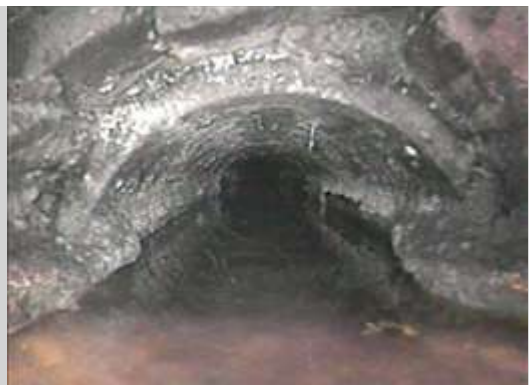
6 O'Clock Inflow

8 in. Circular Gravity Sewer
Pipe In @ 6 O'Clock

Invert Depth: **7.00** (ft.) Flow Characteristics: **Slow**

Deposits: ☐ None ☐ Mud ☒ **Sludge** ☒ **Debris** ☐ Grease

Silt Depth: **1** (in.) Deposits Extent: **Light**
